WATERTIGHT

Driving down leakage

By RS Mckenzie, managing director of WRP Engineers

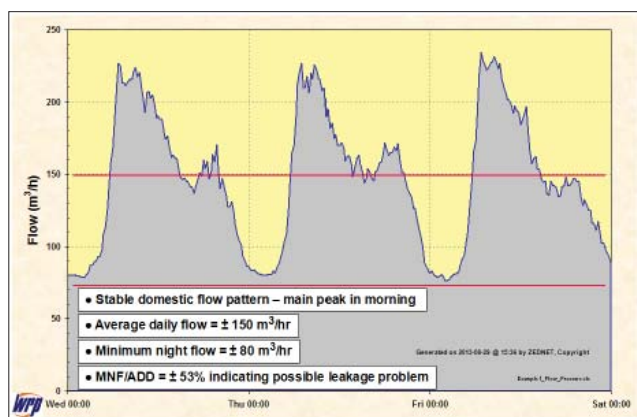
FIGURE 1 Flow entering a discrete zone over a three-day period

A typical flow logging result for a discrete zone over a three-day period is shown in Figure 1. This very simple and clear-cut example indicates a typical domestic demand pattern that is repeated each day and has a morning and evening peak demand together with a minimum demand sometime during the late evening or normally around 02:00 in the morning. As can be seen from the graph, the MNF is around 80 m³/h with an average daily flow demand of approximately 150 m³/h. One of the most useful benefits of a flow logging is to help identify if the zone has a serious leakage problem. The MNF can be analysed with relative ease using the SANFLOW Model developed through the Water Research Commission (WRC, 1999). This model is freely available and is very easy to use and will provide a realistic estimate of what the MNF should be for a specific zone based on the key characteristics of the zone. The unexplained leakage is basically the difference between the expected MNF and the actual MNF.

If the water loss “detective” wishes to get a very rough and ready estimate of whether or not the zone has a leakage problem, they can simply calculate the ratio of the MNF to the average daily demand (ADD). If this ratio is below 20% then there is generally no serious leakage problem and if it is above 20% then there may well be a problem, which should be investigated. In the case of Figure 1, the MNF/ADD is 53%, which clearly indicates that there is a leakage problem.

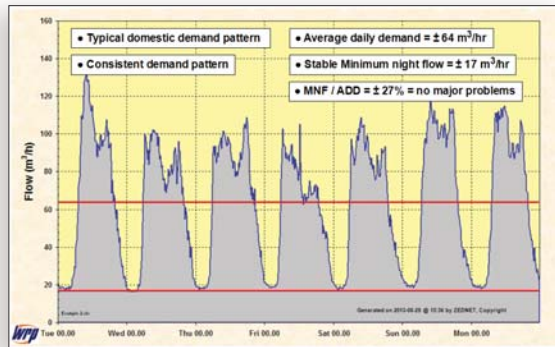
FIGURE 2 Typical seven-day flow logging into a zone

The second example as shown in Figure 2 is a typical flow logging from a discrete zone supplying a residential area. Once again, the typical domestic demand pattern with a morning peak and evening peak can be seen. The MNF is approximately 17 m³/h while the ADD is estimated to be 64 m³/h. The ratio of the MNF to ADD is 27%, which suggests that there may be a small leakage problem; however, in most parts of South Africa this zone would not be considered a high-priority zone for leakage detection and has no major problems.

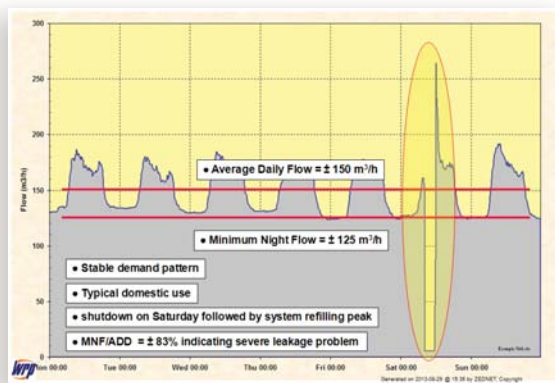
FIGURE 3 Seven-day logging result for zone with serious leakage problem

The third example again shows a seven-day logging result for a discrete zone supplying a residential area. In this case, it is clear that there is a very high MNF, which is indicative of high leakage. This is confirmed by the high MNF/ADD ratio of 83% and there is little doubt that this area has massive leakage. This type of graph is typical in many residential areas where payment for water is low and internal plumbing leakage is very high. The graph also shows the impact of a shutdown on the Saturday where the water supply was cut for several hours. Of interest is the sudden sharp increase in water demand immediately after opening the supply into the area. Such spikes in ‘demand’ are caused by the rapid filling of the pipes, which emptied when the water supply was cut. Great care must be taken when opening the water supply into an area after any shutdown, as such spikes can often damage the water meters in cases where a mechanical meter is used.

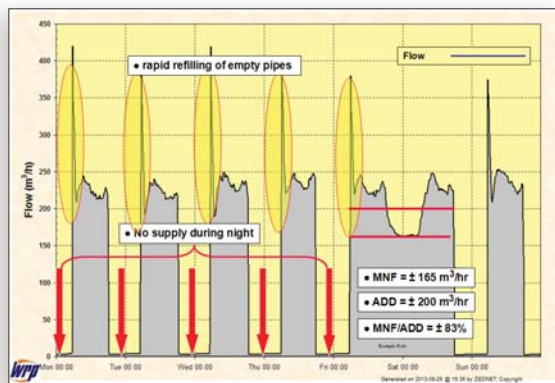
FIGURE 4 Typical flow logging for a zone with intermittent supply

The fourth example shows the logging result into an area of intermittent supply, which is fast becoming a common occurrence in some parts of South Africa and is the norm in most developing countries. Once again the spikes caused by the rapid refilling of the pipes (which can damage the meters) are clearly visible. The issue of air in the pipelines is also a serious problem since it can cause bursts if the air valves are not fully operational. Intermittent supply is a very serious issue and should be prevented if possible. If allowed to continue, the leakage rates in the reticulation system will increase to such an extent that the system will eventually break down completely. In this zone, it was not possible to evaluate the leakage levels due to the intermittent supply that prevented any indication of the MNF. To overcome this problem, the supply was opened for two days so that some estimate of the MNF could be established. As can be seen, the MNF/ADD ration was estimated to be 83%, which suggests extremely high leakage.

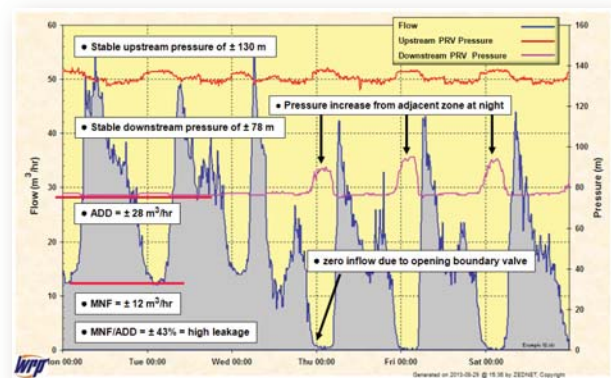
The fifth example, shown in Figure 5, is a more complicated and interesting case in which both pressure and flow are presented for the zone inflow to an area controlled by a pressure-reducing valve (PRV) that was initially thought to be discrete. In this case, it can be seen that after a few days the MNF drops to zero and, at the same time, there is an increase in pressure at the downstream side of the PRV. It should always be remembered that there will always be some level of MNF in a zone and the MNF will never drop to zero, even after rigorous leak detection. If the flow into the zone drops to zero, then it suggests that the MNF is being supplied from another source, which immediately points to some breach in the zone. In this particular case, a boundary valve has been opened, which has little influence during the peak daily demands but during the off-peak demand periods when the inflow to the zone is low, the connection is capable of pushing up the overall zone pressure. When the zone pressure at the downstream side of the PRV increases above

the pressure set at the PRV, the valve closes and all flow through the valve stops – hence the zero MNF.

FIGURE 5 Example of a zone with an open boundary valve

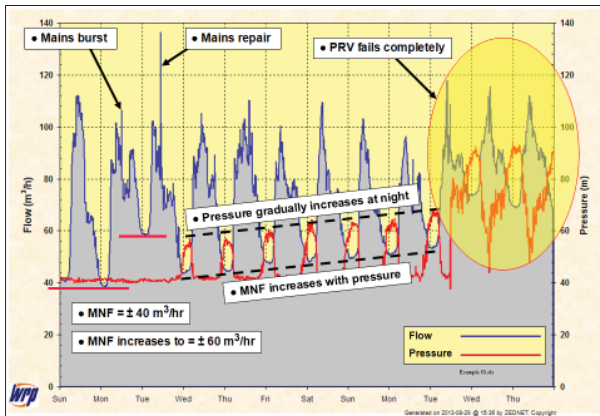
The sixth example is by far the most complicated shown so far and demonstrates a number of interesting issues and clearly highlights the true benefit of monitoring the flows and pressures into an area. Figure 6 shows the flow into a discrete area that is controlled by a PRV. The downstream pressure at the PRV is shown in red. As can be seen, the pressure at the PRV is constant for a few days after which it increases at night much in the same manner as shown previously in Figure 5. In this case, however, the increase in night-time pressure is not due to the opening of some cross-boundary connection, but rather the failure of

the PRV to maintain a constant downstream pressure. If the pressure increase was due to an open cross-boundary connection, the PRV would have closed with a subsequent drop in the MNF. In this case, it can be seen that the MNF increases, which is due to the increase in leakage caused by the higher pressure. Basically, this graph from a South African installation in Johannesburg depicts quite a complicated story and has been used in many textbooks around the world to demonstrate

FIGURE 6 Example of logging result caused by leak and PRV failure

the value of logging pressure and flow. The problem starts with a reasonably large mains burst in Day 2, which is evident from the spike in flow (as noted on the graph); this in turn creates a sudden increase in the MNF of about 20 m³/h. An average mains burst would be around 6 m³/h and so this burst is relatively large. The repair takes place on the following day and a spike in flow is evident, which is possibly due to some refilling of empty pipes after the water supply is restored to the area that had been isolated during the repair. It can be seen that the MNF drops back to near pre-burst levels on Day 3.

At this point, the PRV starts to fail for some reason and the failure gradually becomes worse over a period of a week after which it fails completely.

The example shown in Figure 6 requires time to fully understand, but is one of the most interesting logging examples found to date. It not only provides a history of the failure of a PRV, but clearly highlights the pressure-leakage relationship of the area where the MNF gradually increases over the seven-day period in response to the gradually increasing night-time pressure.

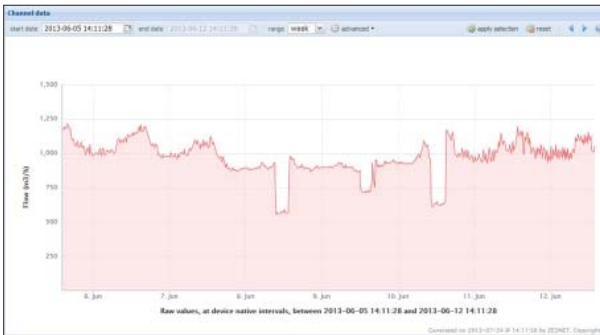
FIGURE 7 Flow logging into a large industrial area

The logging result shown in Figure 7 depicts the inflow to a large industrial area. It tells an interesting story and highlights some very serious issues. Firstly, if the first two days of logging are considered, it can be seen that the MNF is around 1 000 m³/h and the ADD is around 1 100 m³/h. While night-time use can be expected in an industrial area, it is highly unlikely for it to be in the order of 90% of the average daily demand. Typically, a value of 30 or 40% would be expected and, in this case, the high MNF is an indication of very serious leakage.

Another interesting issue highlighted by the graph concerns the two large drops in flow on 8 and 10 June. The first drop occurred when the supply to a small factory was temporarily cut in order to install a new water meter to the factory. The project team undertaking the meter installation had closed a small section of pipe approximately 100 m in length in order to cut in the new meter and when they checked the flow logging results that evening on the internet, they picked up a drop of almost 350 m³/h going into the area. Initially they thought this must have been an error and they repeated the valve closures again two days later on 10 June and picked up the same result. What this result has identified is a leak of more than 300 m³/h from a very

short section of pipe at a cost of over R13 million per annum to the municipality. While it seems implausible that such a large leak could remain undetected for any length of time, it is estimated that it has been running for years! The factory owners on each side of the nearby swamp area were told that the swampy marshland was due to groundwater and has been in existence for many years. This is a nice example highlighting the benefits of real-time flow monitoring and also touches on the concepts of “step-testing” in which small sections of a reticulation system are isolated and the impact on the MNF is monitored. In this case, it was not necessary to look at the MNF as the impact was so significant that it was evident from the normal daily flow.

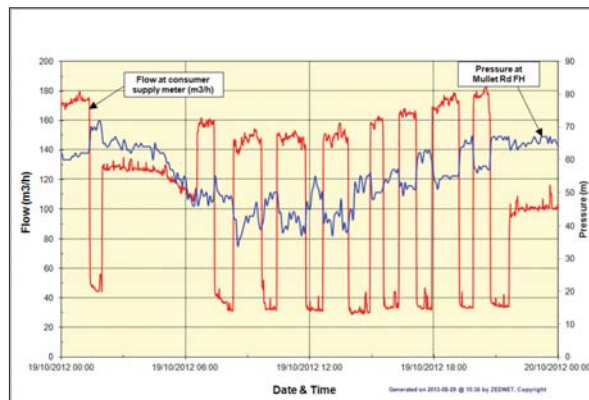
FIGURE 8 Flow logging into an industrial consumer

consumers, particularly large industrial water users as can be seen from the graph shown in Figure 8. The graph shows the flows being used by a relatively large industry and it is clear that some form of tank is being filled every hour or two. This practice of intermittent filling causes serious pressure fluctuations in the water reticulation system in the vicinity of the industry and was creating problems for the municipality and other nearby

industrial users. On presentation of the logging results to the industry in question, they were happy to modify their abstraction process to a more constant rate of abstraction that would not create large pressure fluctuations in the reticulation. Industries are often unaware of the demand pattern they impose on the municipal network and the live logging is of great use and interest to their water managers who generally wish to ensure that they are using water responsibly.

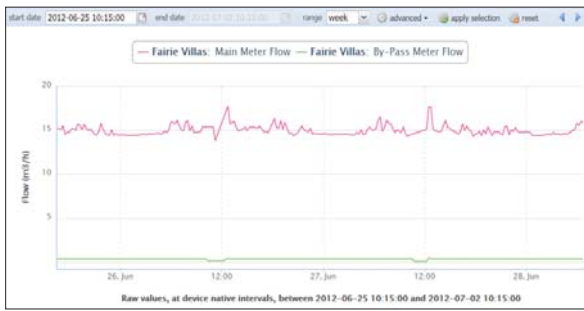
Another interesting example is presented in Figure 9, which shows the flow entering a small complex containing around 50 townhouses. After receiving an unusually high water account for two consecutive months, which was approximately R50 000 higher than normal, the owners realised that it was not a mistake and that they had a leak. A GSM/GPRS logger was installed for a few days and immediately picked

FIGURE 9 Flow logging result into small townhouse complex

up the fact that there was a leak of approximately 14 m³/h within the complex. The leak was repaired and the water use dropped back to normal in the following week. This example highlights the fact that such flow logging is not limited to large users, but can also be very useful to small townhouse developments. The typical cost of such a logger and the annual communication charges is generally between R10 000 and R20 000 per annum, which is often well below the cost of water lost through even a modest leak. Such logging is also very useful in identifying any small leak that is
